PROJECT PROFILE

Progressive Solutions

Commerce Bank
Interstate Shopping Center
1 Interstate Shopping Center
Ramsey, NJ
Project Date: June 2007

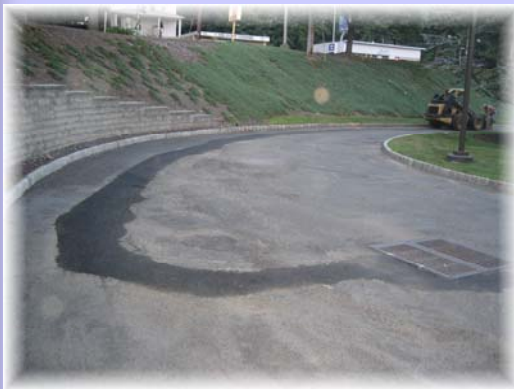
**Drive Thru After Drainage Tile
Installation To Redirect Water Away From
The Retaining Wall**

We were able to install a drainage tile system to collect the underground water and redirect it to a storm drain the first night during the time allotted to us from the Ramsey Police Department. We made special arrangements with the asphalt plant to be able to acquire the needed drainage stone and asphalt to finish Phase I of the project. During the same night, we patched most of the deep pot holes.

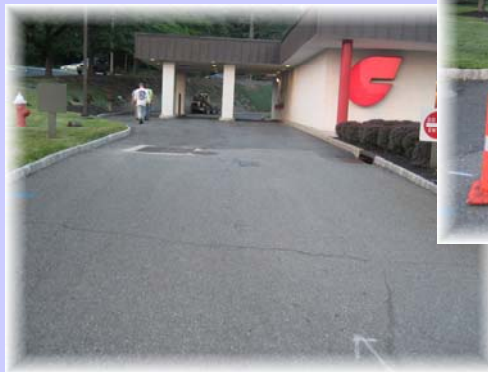
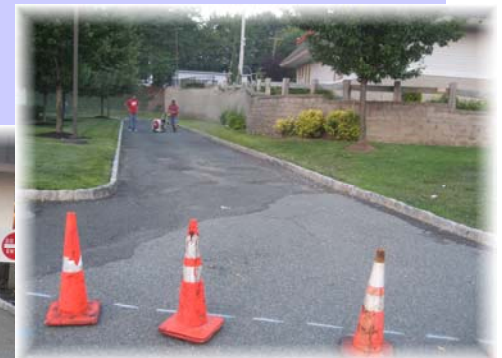
PROJECT PICTURES (BEFORE)

Commerce Bank Corp. leases an outparcel in the Interstate Shopping Center where this project was located. The outparcel is small in size and only contains the footprint of the bank branch, drive thru and five parking stalls. Over the past two years, the drive thru has deteriorated at a rapid rate and during the winter months was developing pot holes so large that customers were avoiding using the drive thru for fear of damage to their vehicles. Brahney Pavement Solutions was asked to provide a thorough site analysis and cost proposal to remediate the damage. A site analysis was performed and it was determined that the pot holes and alligator cracking were being caused by either a underground spring or water runoff that was creating a high water table in the area of the drive thru. The bank is located in a small cubbyhole that is below grade. The property is surrounded by a large retaining wall on two sides of the drive thru and in the area where it was determined that most of the water damage was occurring. Armed with a site analysis complete with pictures and a cost proposal, we submitted the proposal and our findings. The contract was awarded to our company two weeks later.

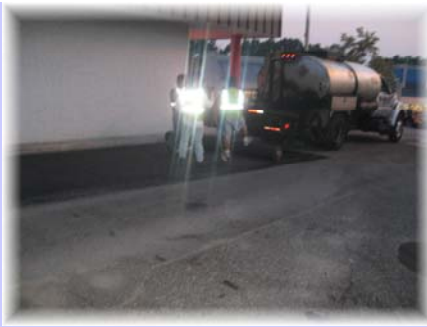
Geotextile Waterproofing Membrane Being Installed Prior To The Paving

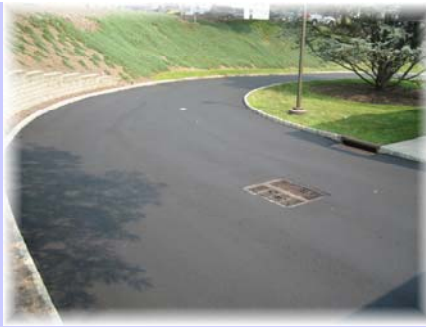
COMPLETED PROJECT!

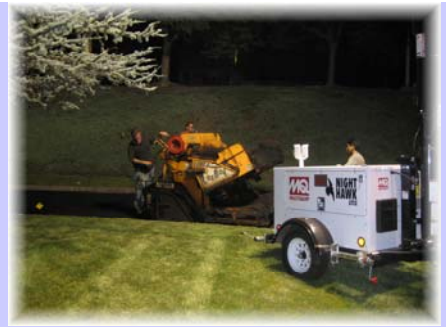
Asphalt Paving Being Performed Under A Light Tower For Quality Control

The second night we had all necessary equipment staged on site at 7:00 PM. The first batch of dump trucks loaded with fresh plant hot mix asphalt arrived at 7:45 PM. We made arrangements for the asphalt plant to remain open until the project was completed. Promptly at 8:00 PM after the drive thru and bank closed for business, light towers were erected to illuminate the work areas, a cleaning crew began the preparation work, transitions were milled for a clean tie in with the existing asphalt, and a geotextile waterproofing membrane was installed to prevent any further water from pumping to the surface. The paving crew began paving at 8:45 PM and by 10:00 PM had installed 125 tons of asphalt for a project completion. The equipment was parked back in the designated staging area awaiting pick-up the following morning and the entire job site was cleaned thoroughly.

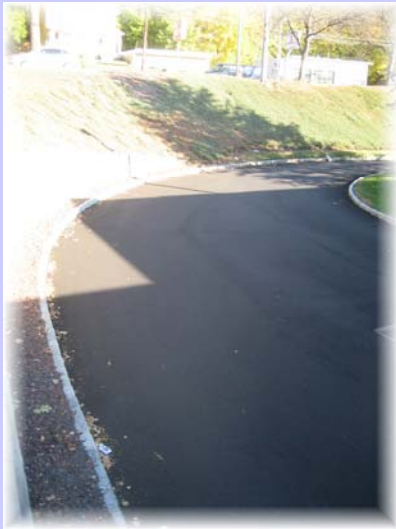
(LEFT) Project picture taken 6 months after completion after 2 weeks of heavy rain. Notice no water on the blacktop. This is due to the waterproofing membrane installed.

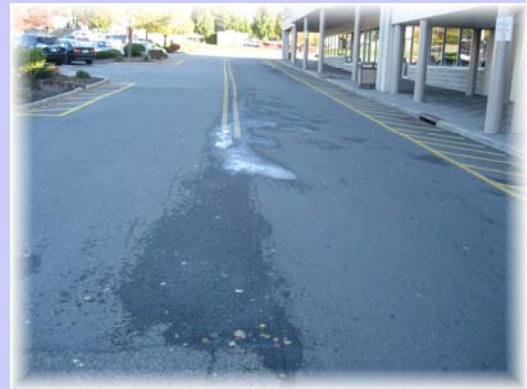
(RIGHT) This pictures was taken in the same shopping center the same day as the picture on the left, however, you can see the water pumping to the surface from the last contractor who paved the lot without using a waterproofing membrane.
